ANGA/APSC Conference December 2024

Accident Investigation
Division (AID)

Case Study
Atmos Energy
Dallas, Texas
Gas Migration
One Fatality and
Three Injuries
February 23, 2018

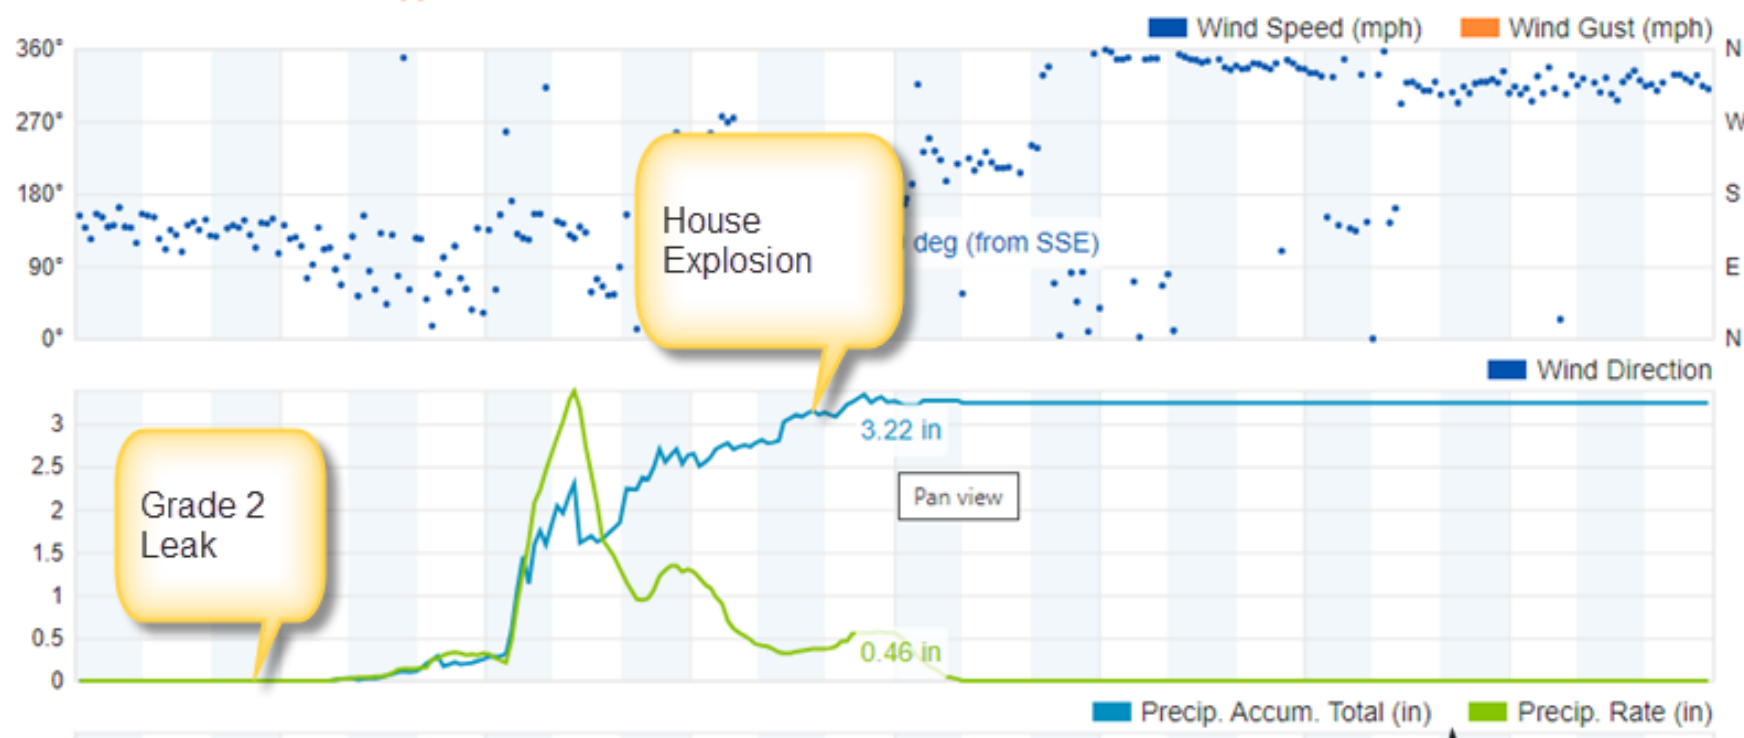
* Each bar represents 1-hour. 5 hours of heavy rain capped the gas plume. Leak was graded 3 months prior to explosion.

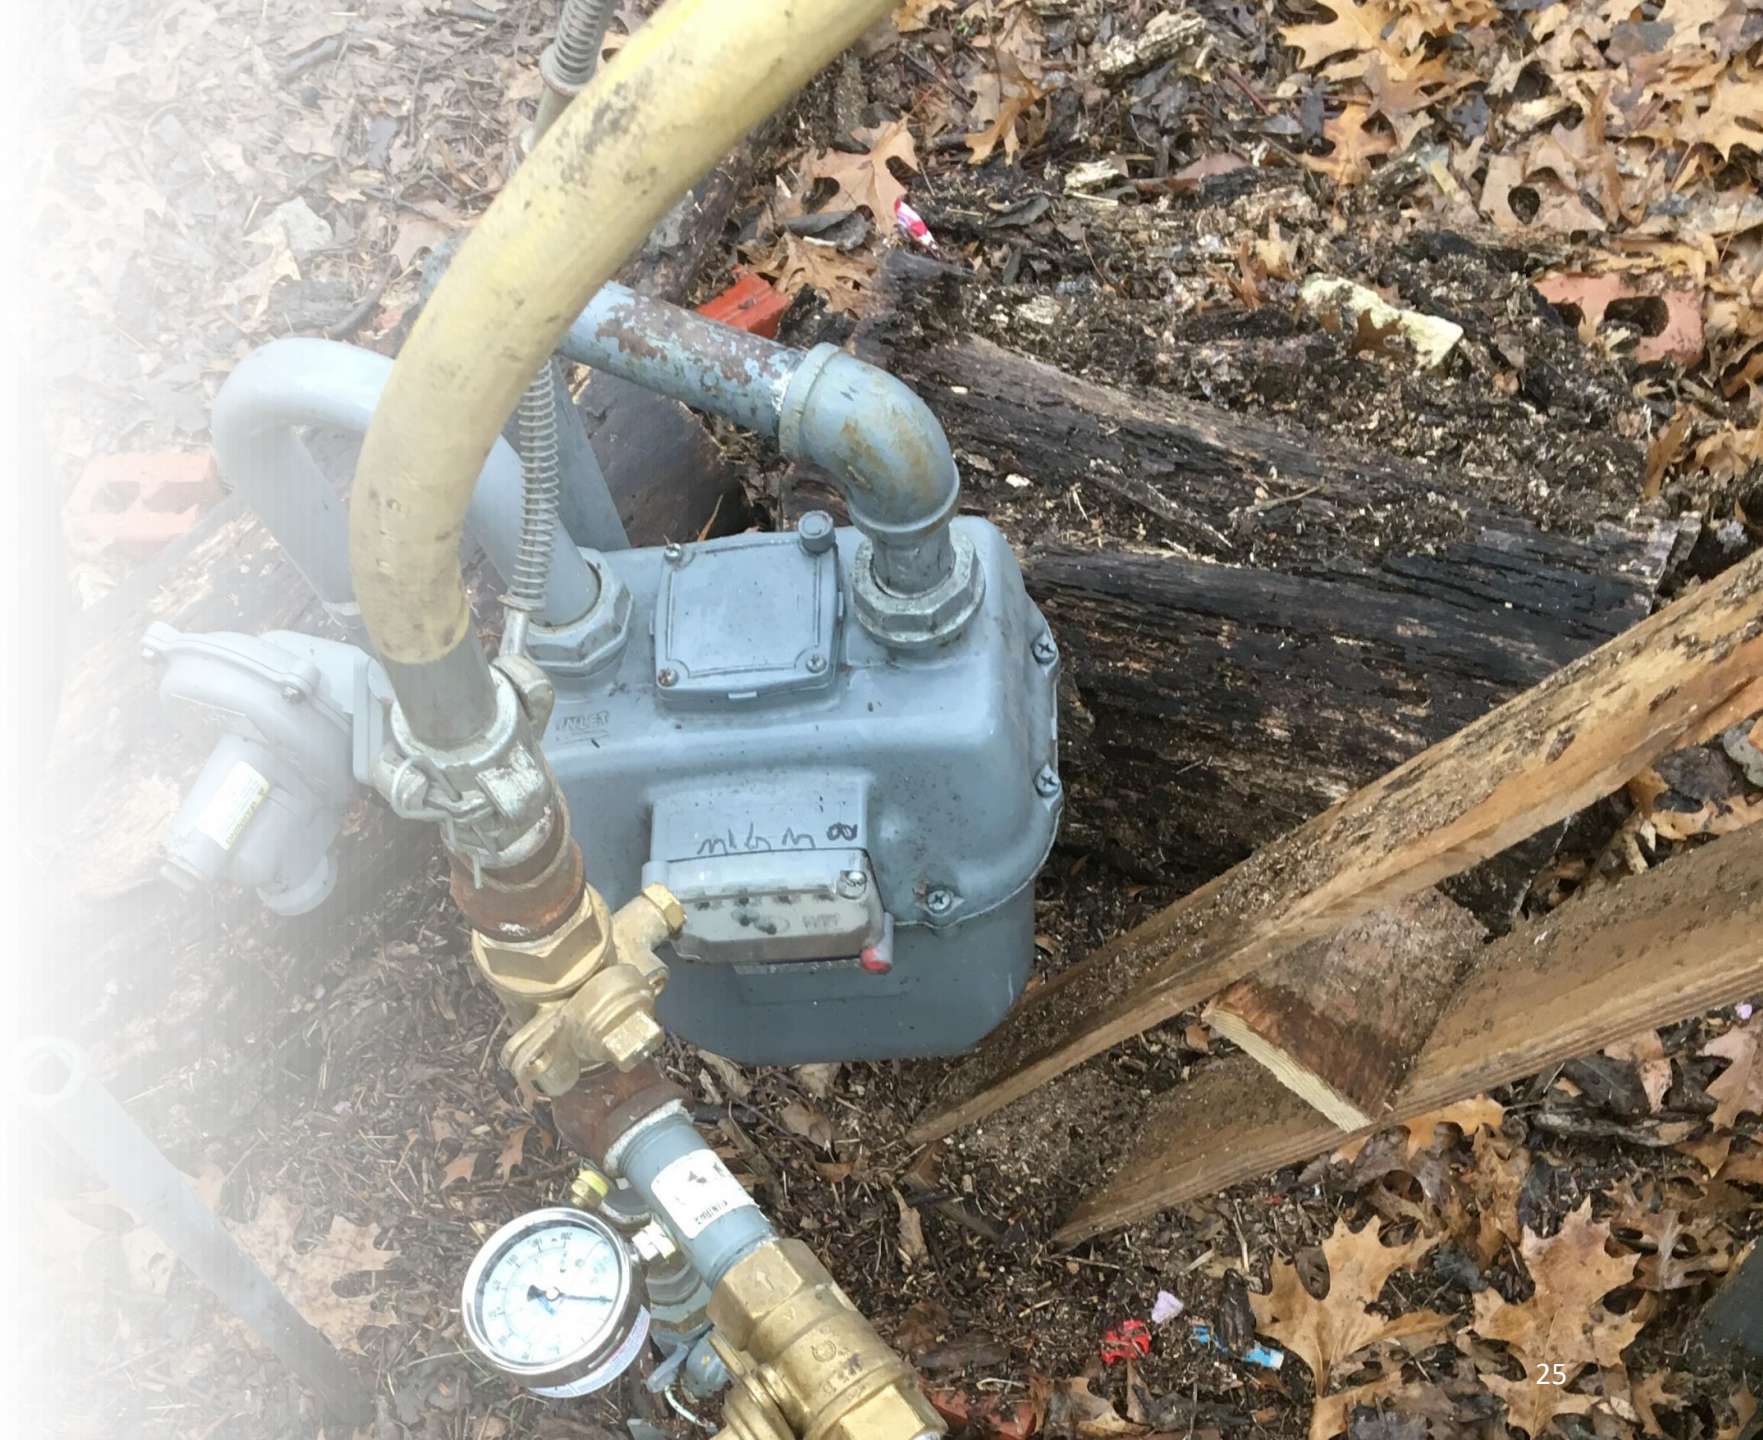
Mains and services capped and ready for pressure testing.

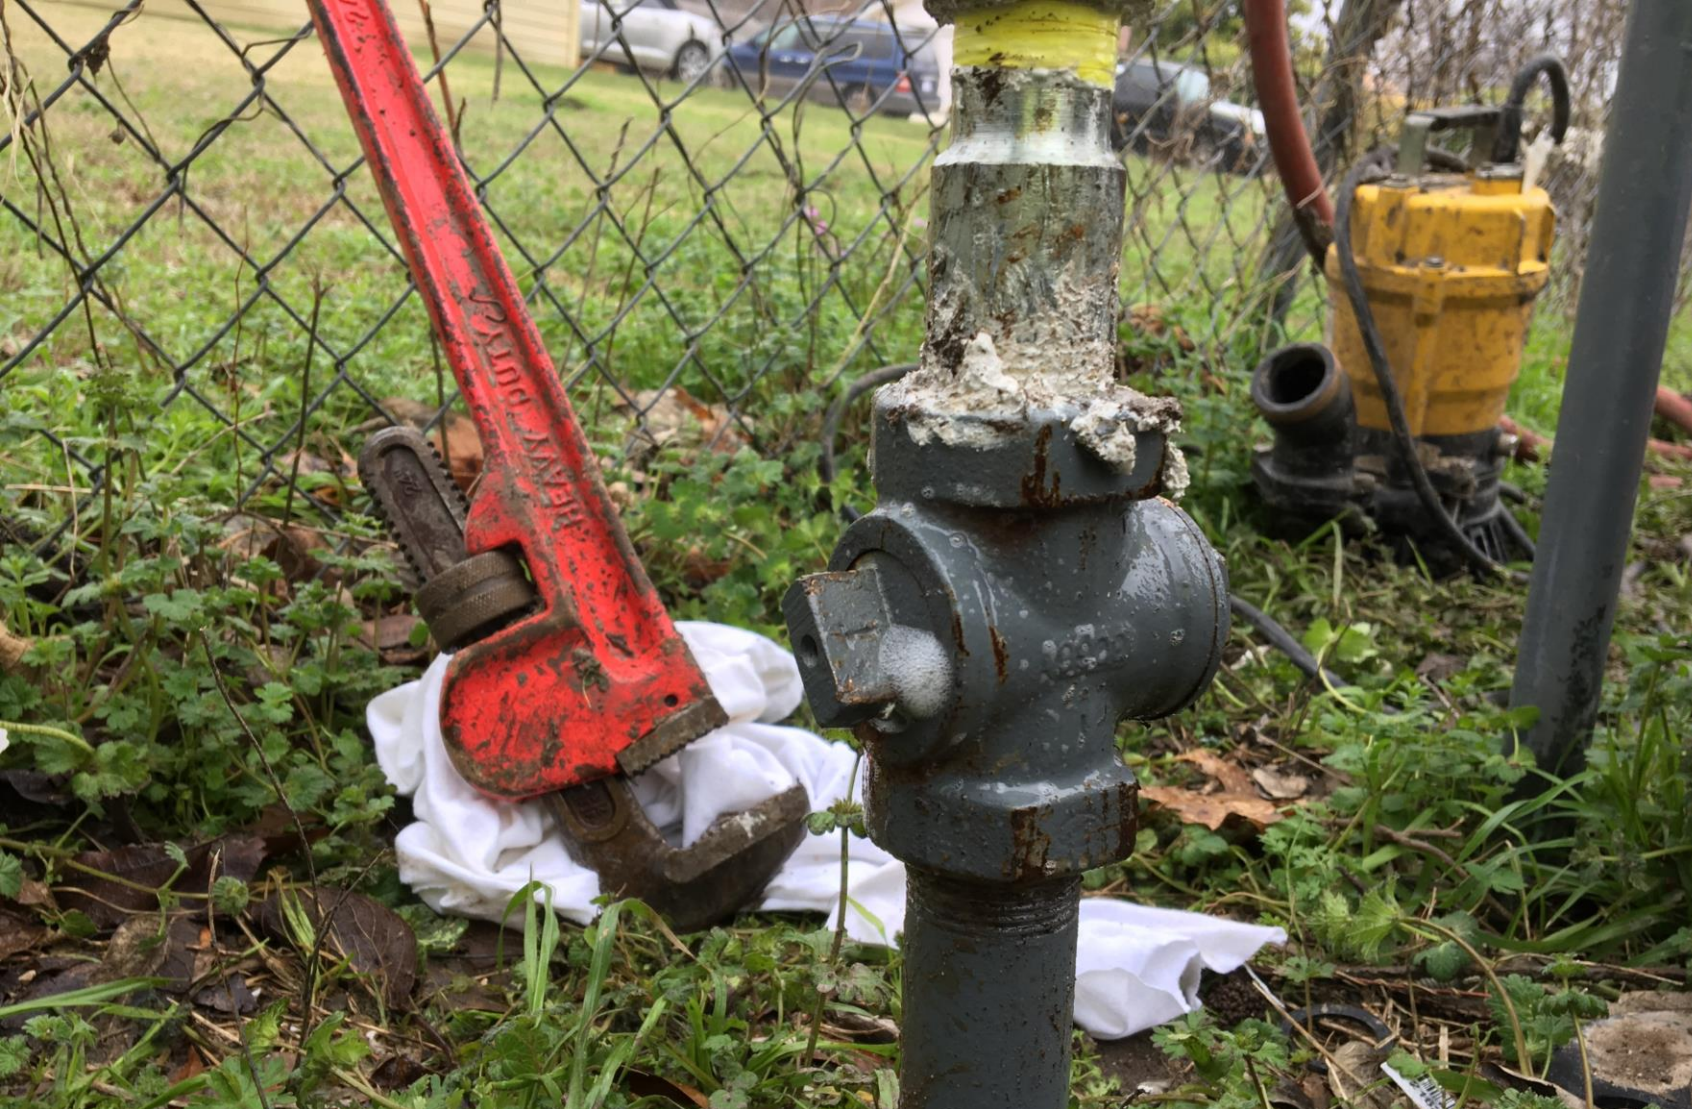
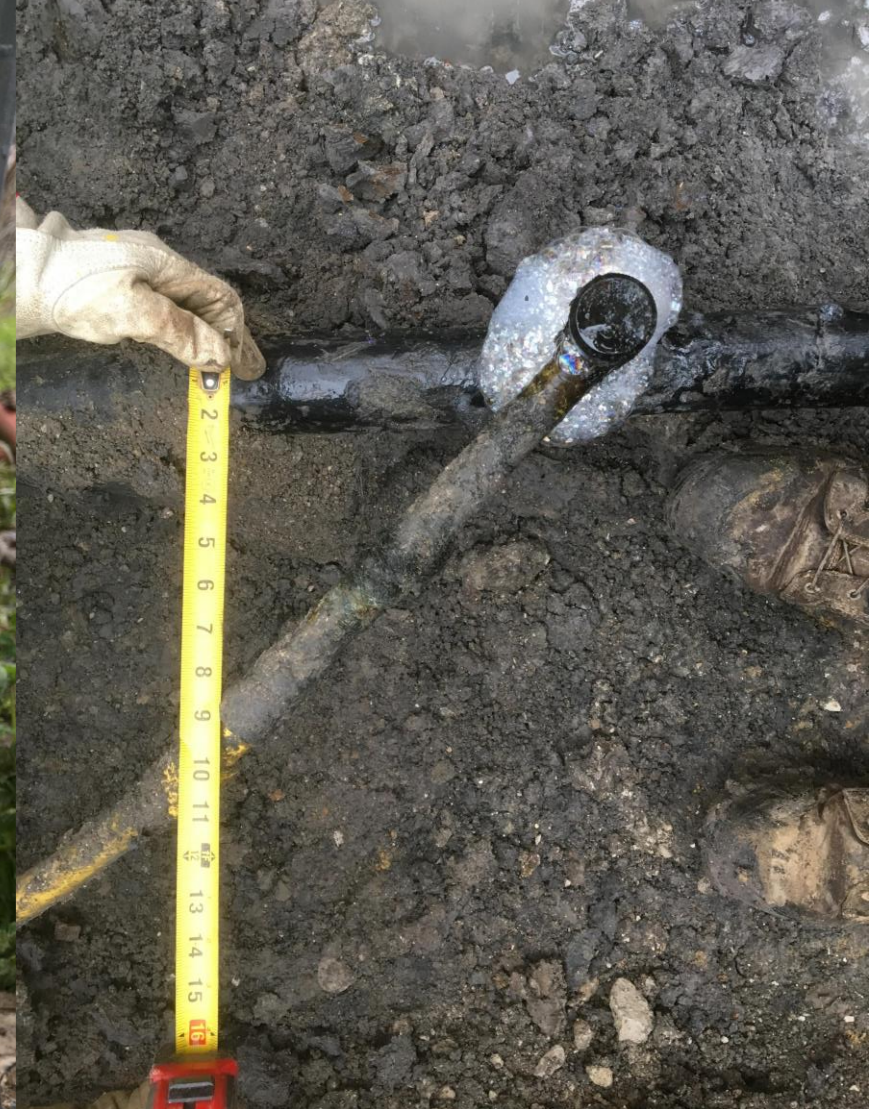
Leaks at service tee and stopcock. Some leaks will cause test pressure failures but are not hazardous. The flow rate will be inadequate to migrate any distance. Flow rate testing pipelines that fail pressure tests should be performed prior to exposing buried leaks.

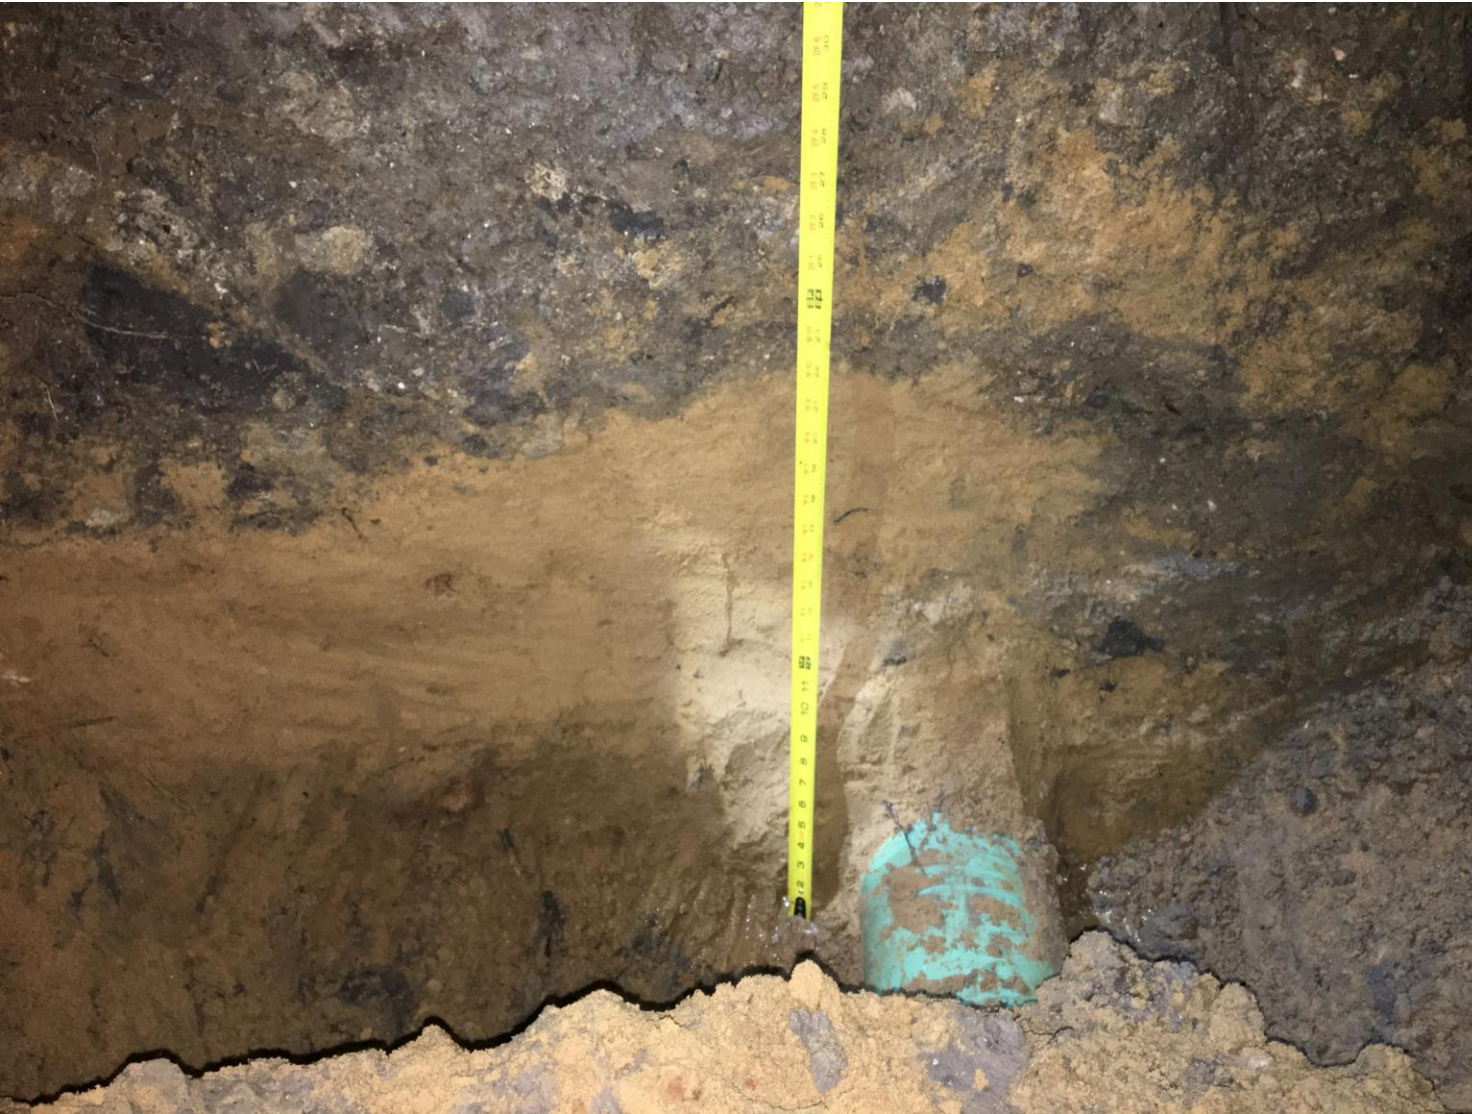
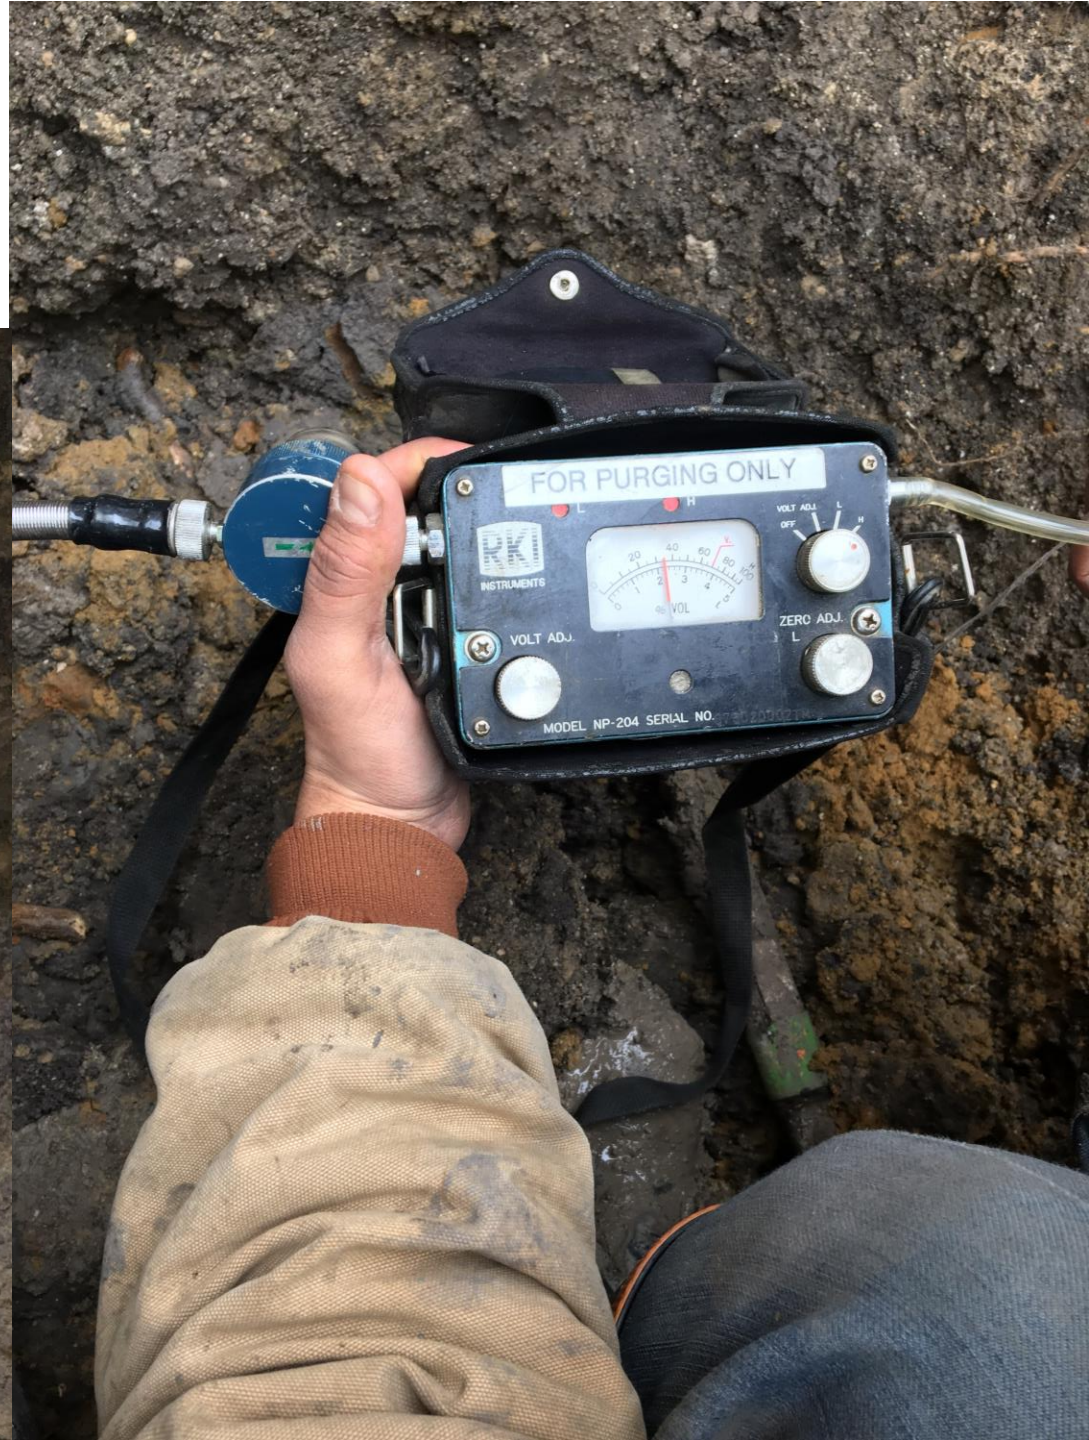
During excavation pay close attention to what is being dug up. Evidence can be anywhere. Sand bedding for sewer line was conduit for gas migration. Test and document to confirm theory. CGI shows 35% LEL, 9 days after the gas was shut-off.

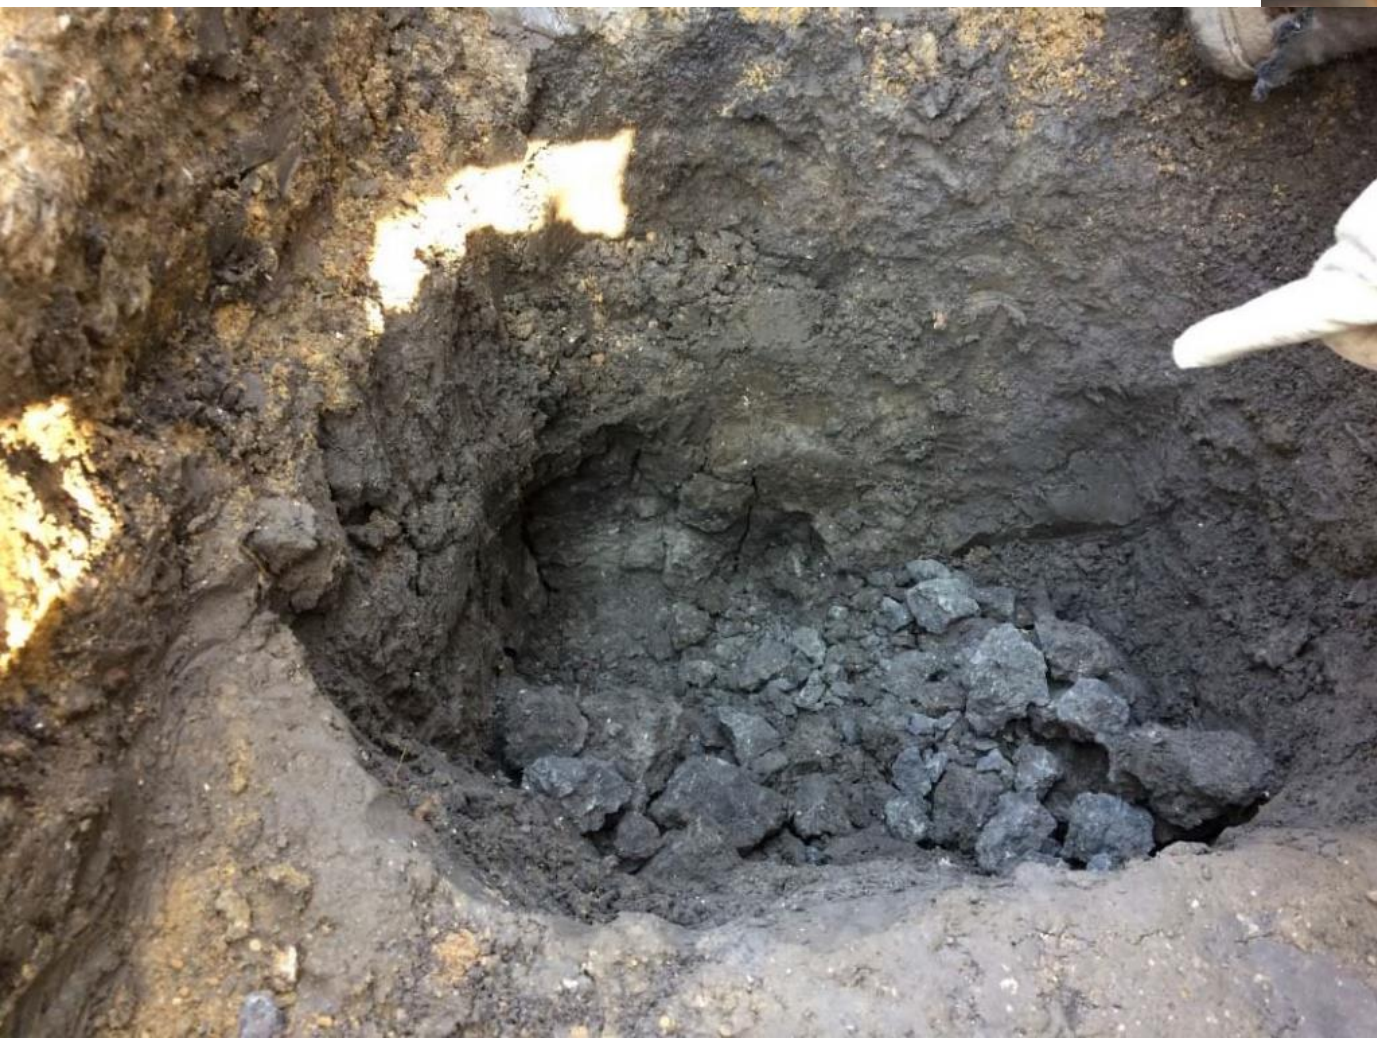
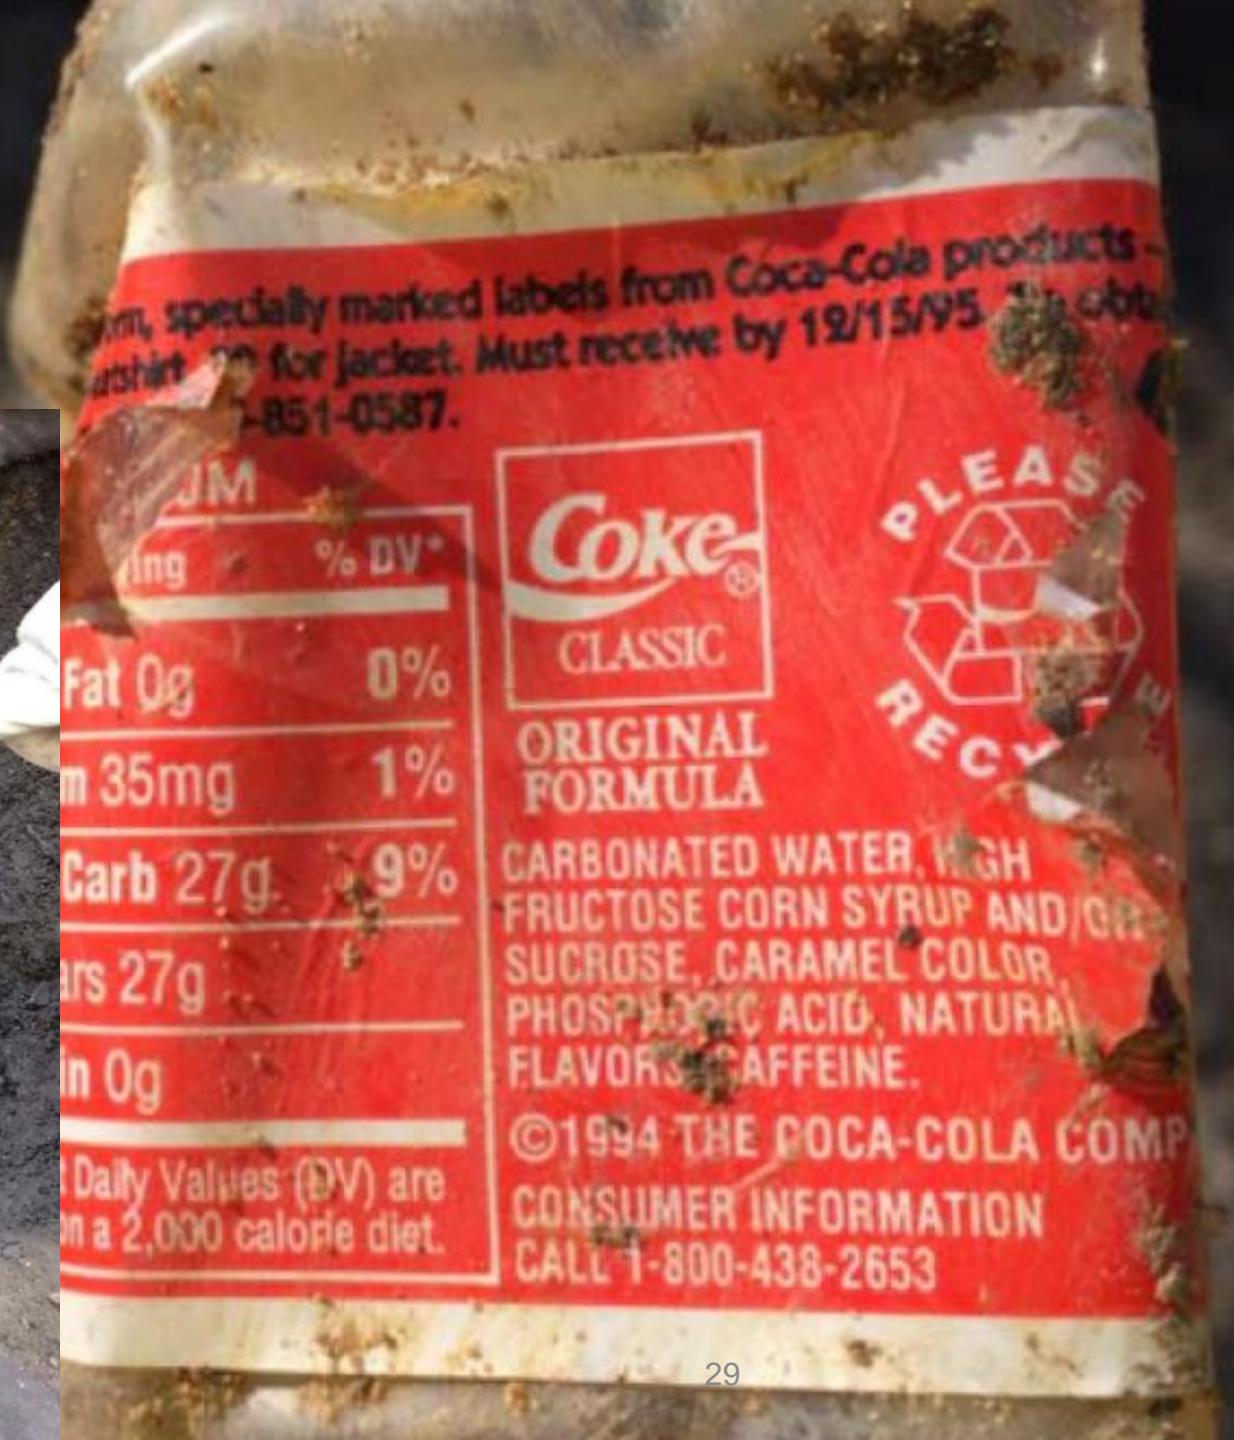
Evidence can be anywhere. Soil will discolor from the release of natural gas, dry out and scrub odorant. A dated coke bottle found next to main failure. Date corresponds to sewer installation.

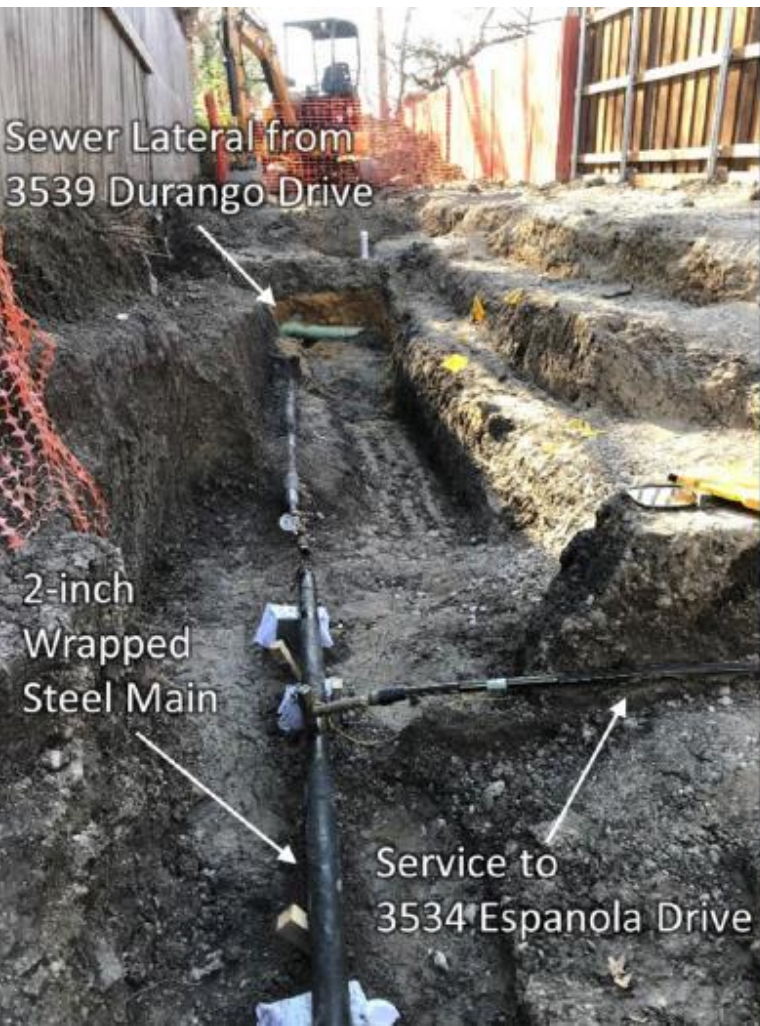
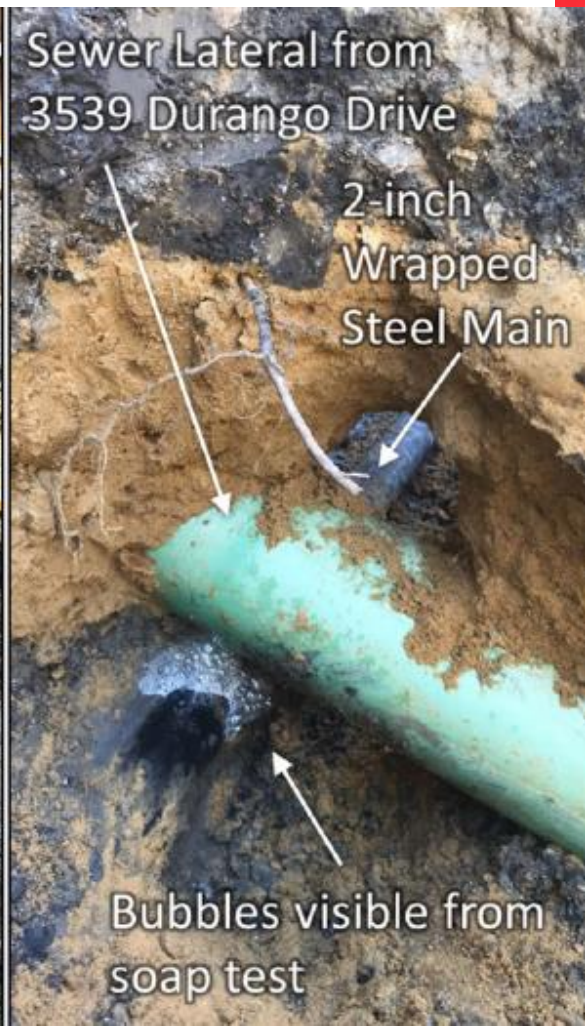
Source of the gas was identified at a location where a sewer main was installed in 1995, with only 2-inches of clearance. The line was dented and gouged with excavation equipment and failed 23 years later as a circumferential crack.
