ANGA/APSC Conference December 2024

Accident Investigation
Division (AID)

Case Study
Atmos Energy
Dallas, Texas
Gas Migration
One Fatality and
Three Injuries
February 23, 2018

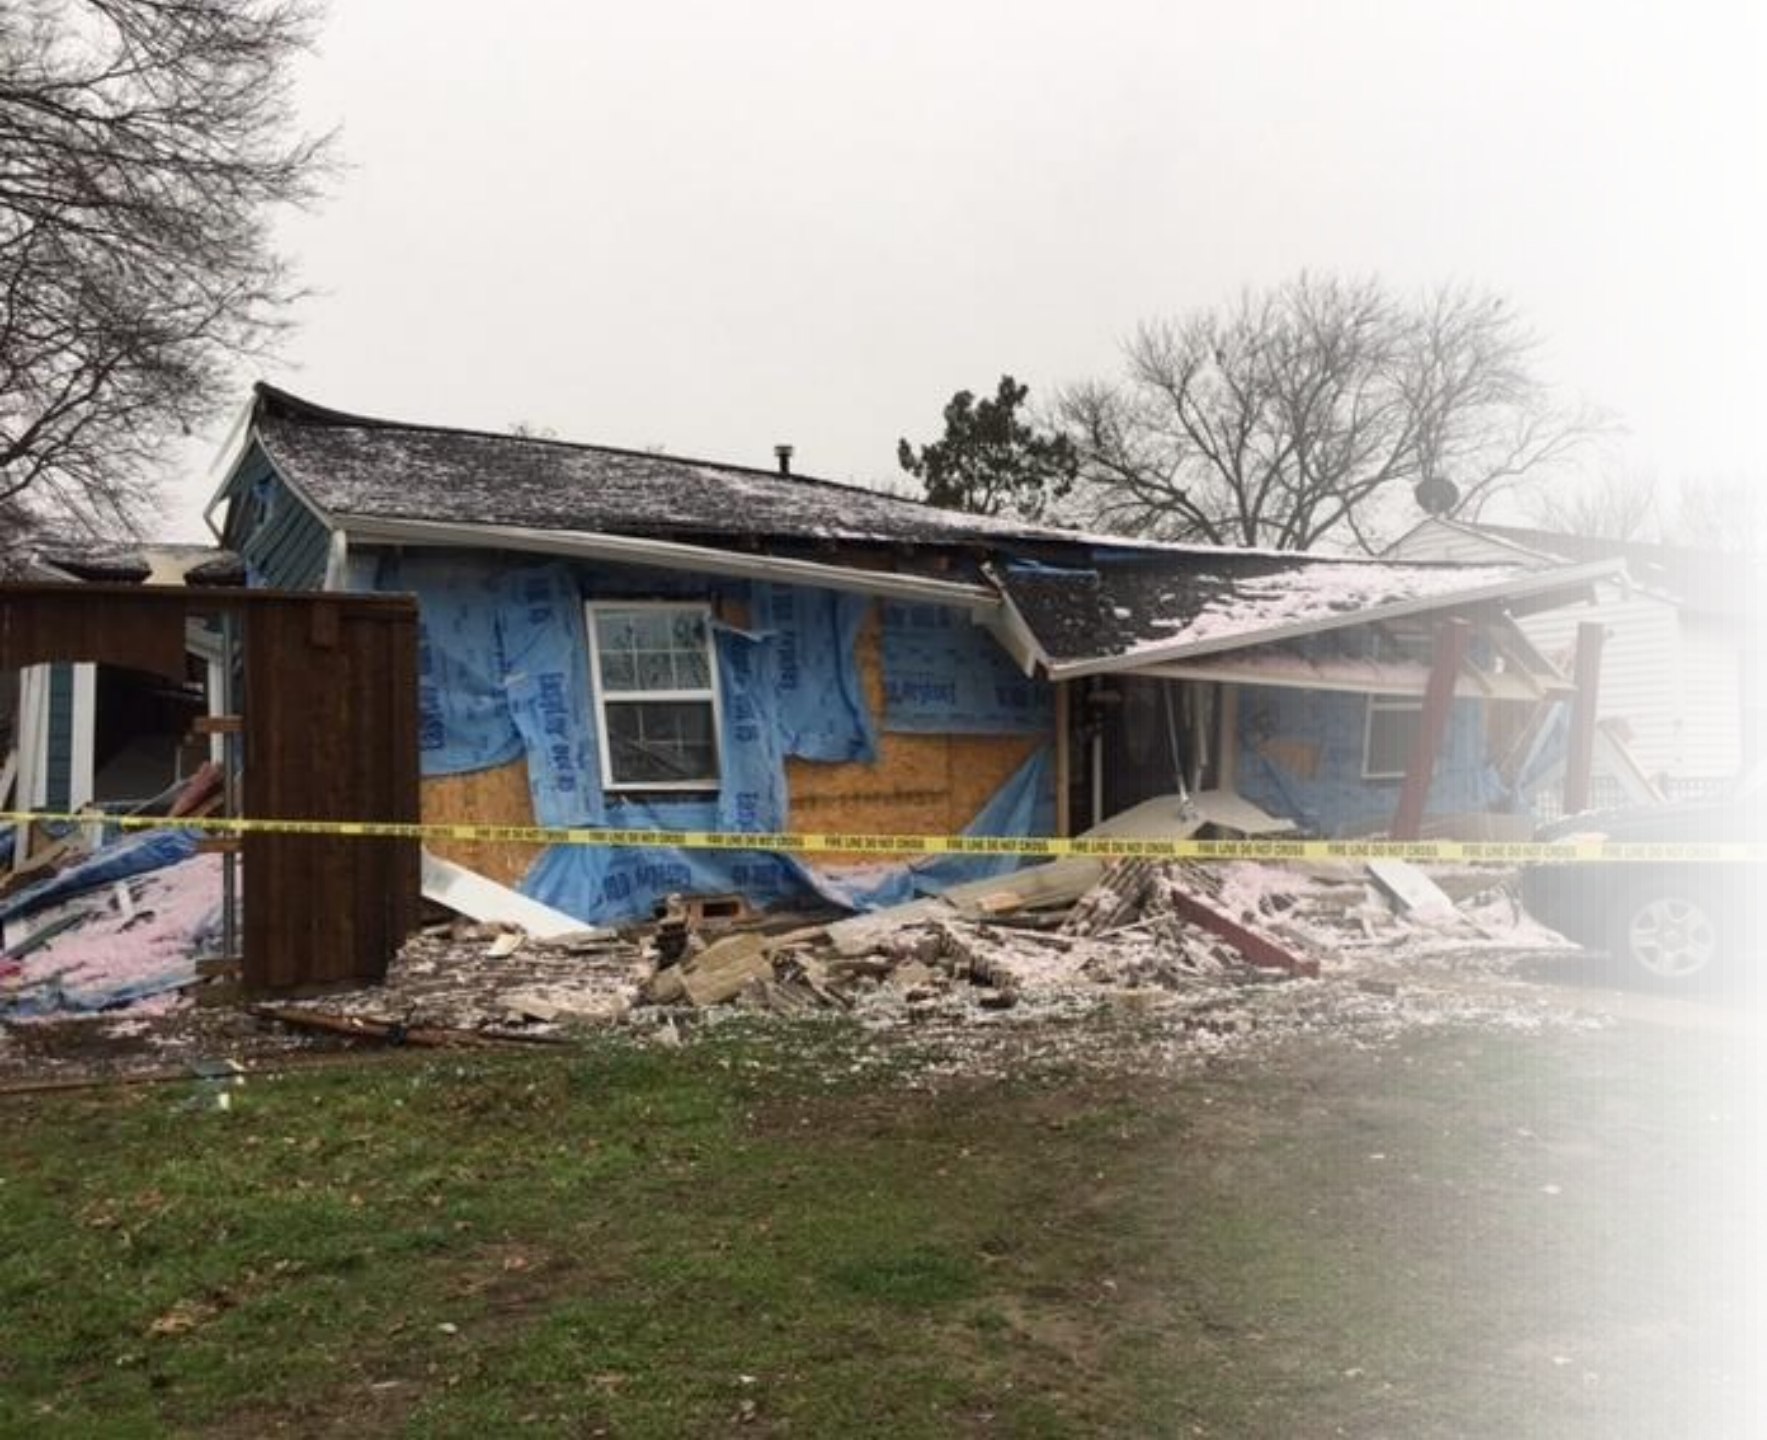
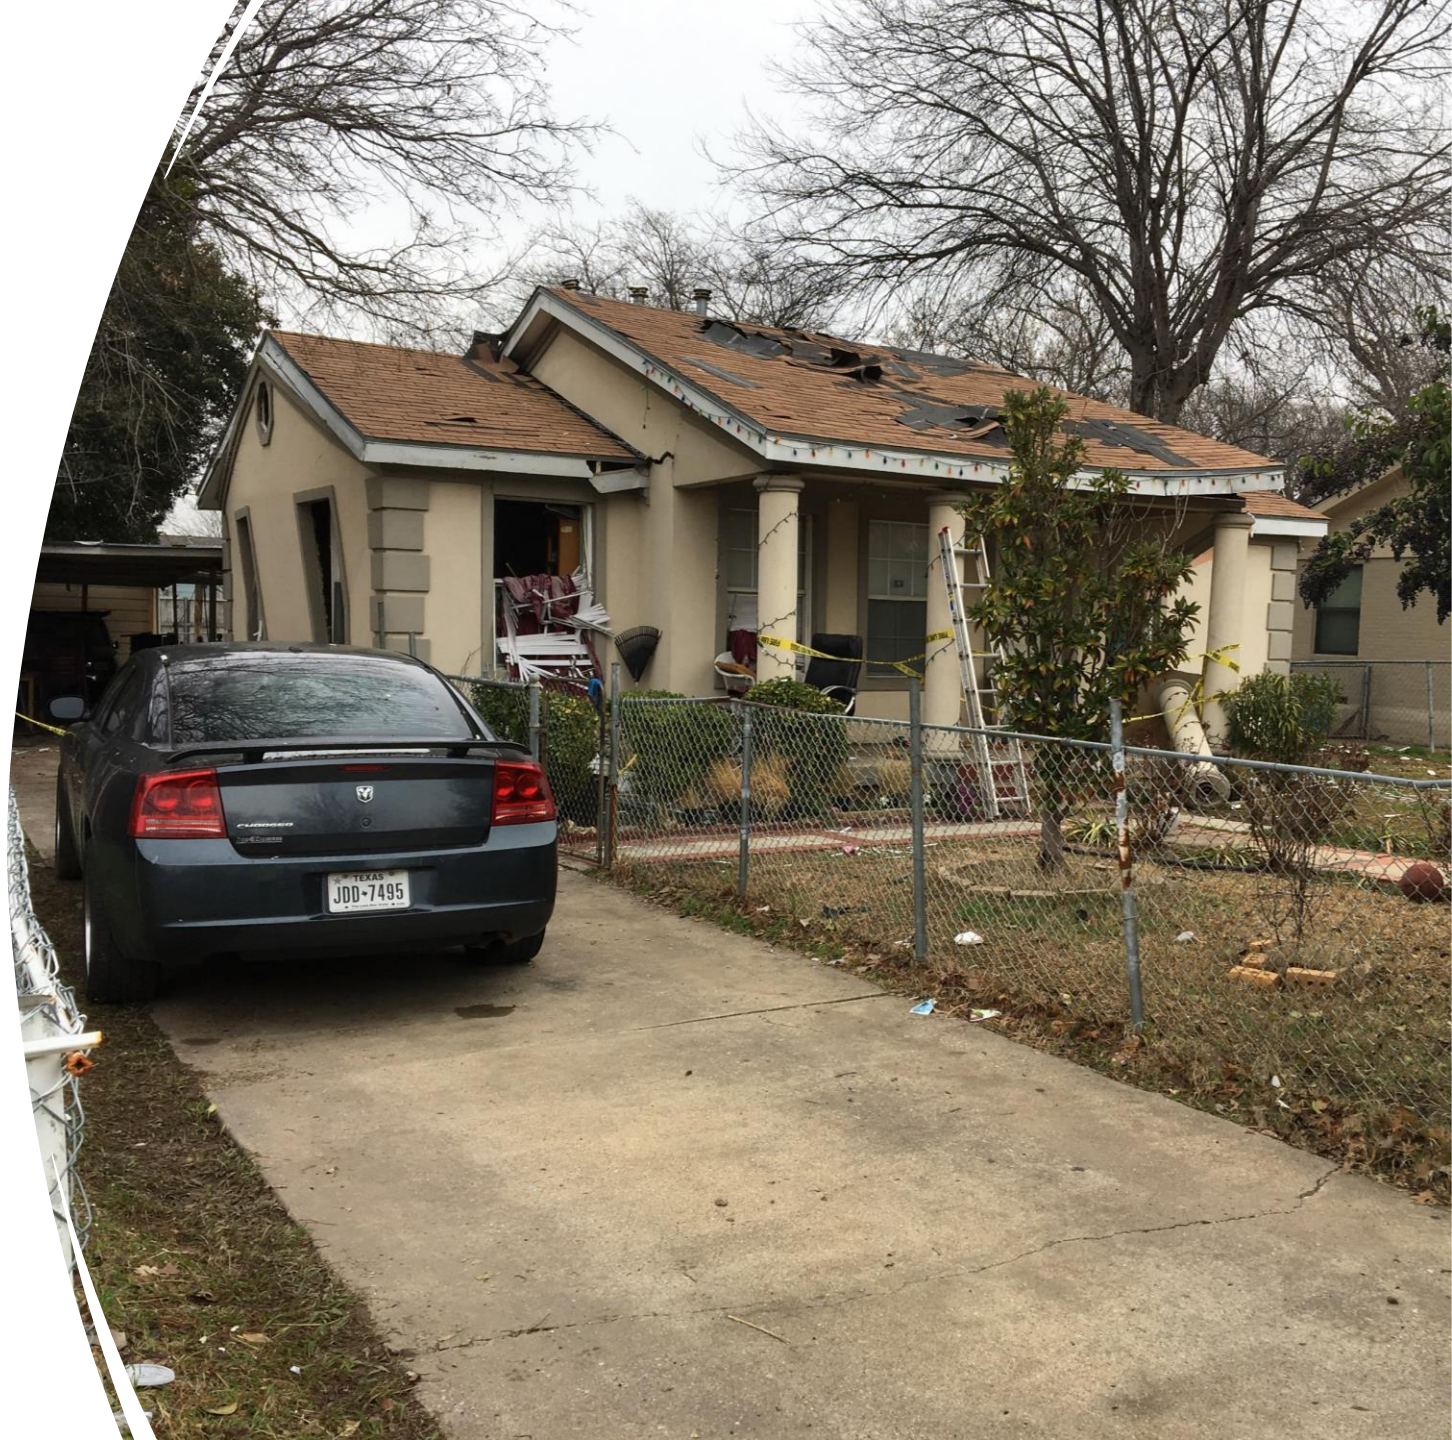
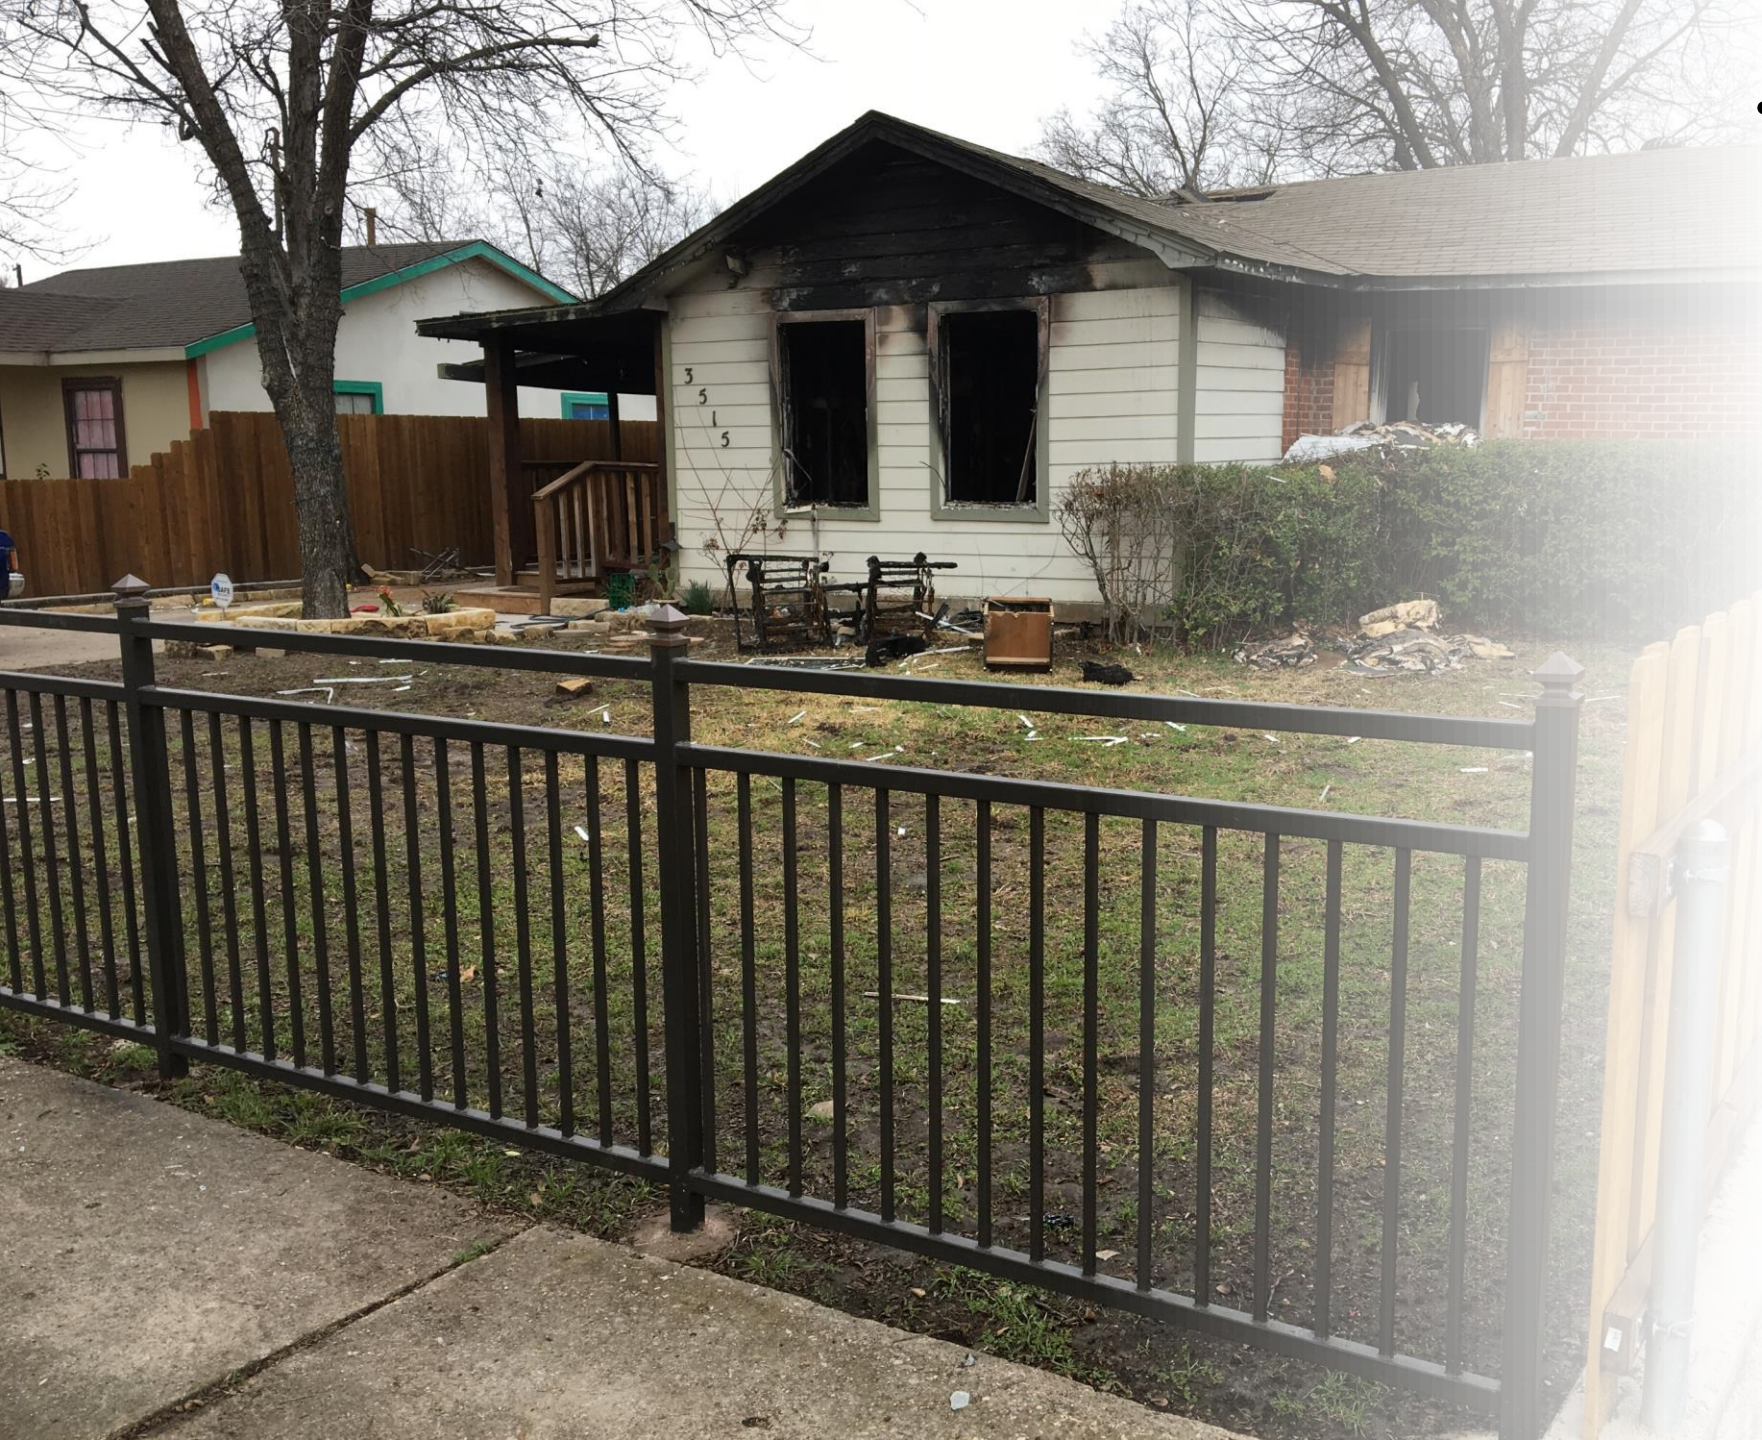
- February 21, 2018 – Day 1
 - House 3527 has an incident at 5:49 a.m.
 - Homeowner heard a popping noise in the attic where the heater unit is located. He investigated and found the steel cover to the furnace not on the unit.
 - When the cover was reinstalled, the furnace operated the pilot-light igniter operated and an explosion occurred throwing him backwards. He never smelled any gas odor.
 - Arson investigators responded and determined the cause as “undetermined”.
 - Gas company was also on site but not allowed to test service due to structure damage.
 - Ground saturated from exceptionally heavy rains

- February 22, 2018 – Day 2
- House 3515 has an incident at 10:21 a.m.
- Homeowner was alone and began to boil some water when the flames acted erratically and began to grow out of control and engulfed him.
- Fire traveled to attic causing additional damage.
- Arson investigators interviewed the witness and determined that it was an appliance issue.
- No gas odor detected by resident
- Rain continuing

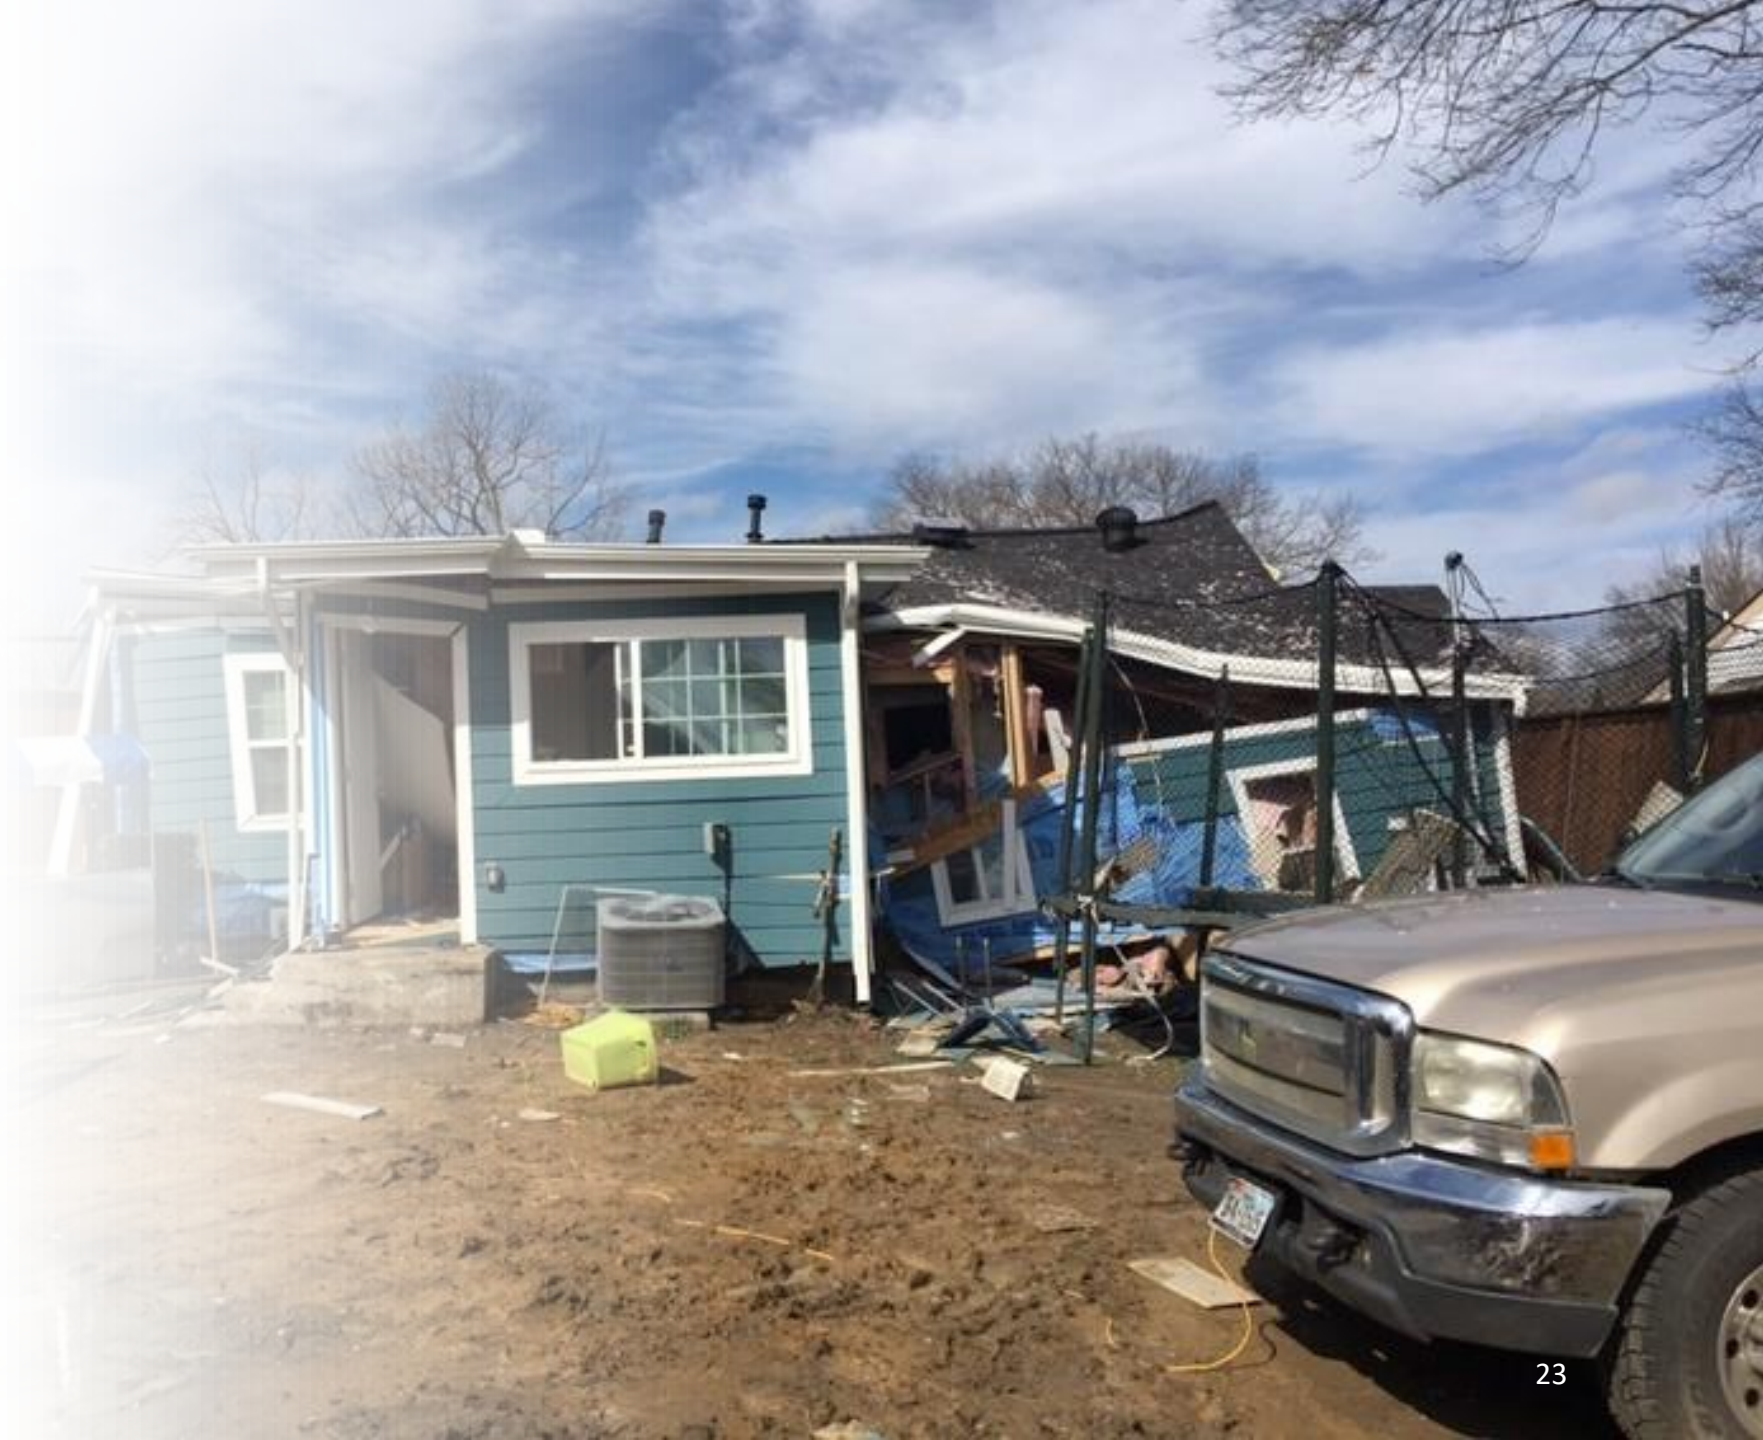
- February 23, 2018 – Day 3
 - House 3534 has an incident at 6:38 a.m., with a fatality and 3 injured, 1 released
 - Lived in home one month after full renovation. Including new gas and sewer service lines to alley.
 - Homeowner heard a loud pop in kitchen around 11 p.m. but found no source.
 - No gas smell prior to explosion
 - TX-RRC, NTSB and PHMSA launched to investigate.

Leak surveys were performed after each explosion, with RMLD and CGI.

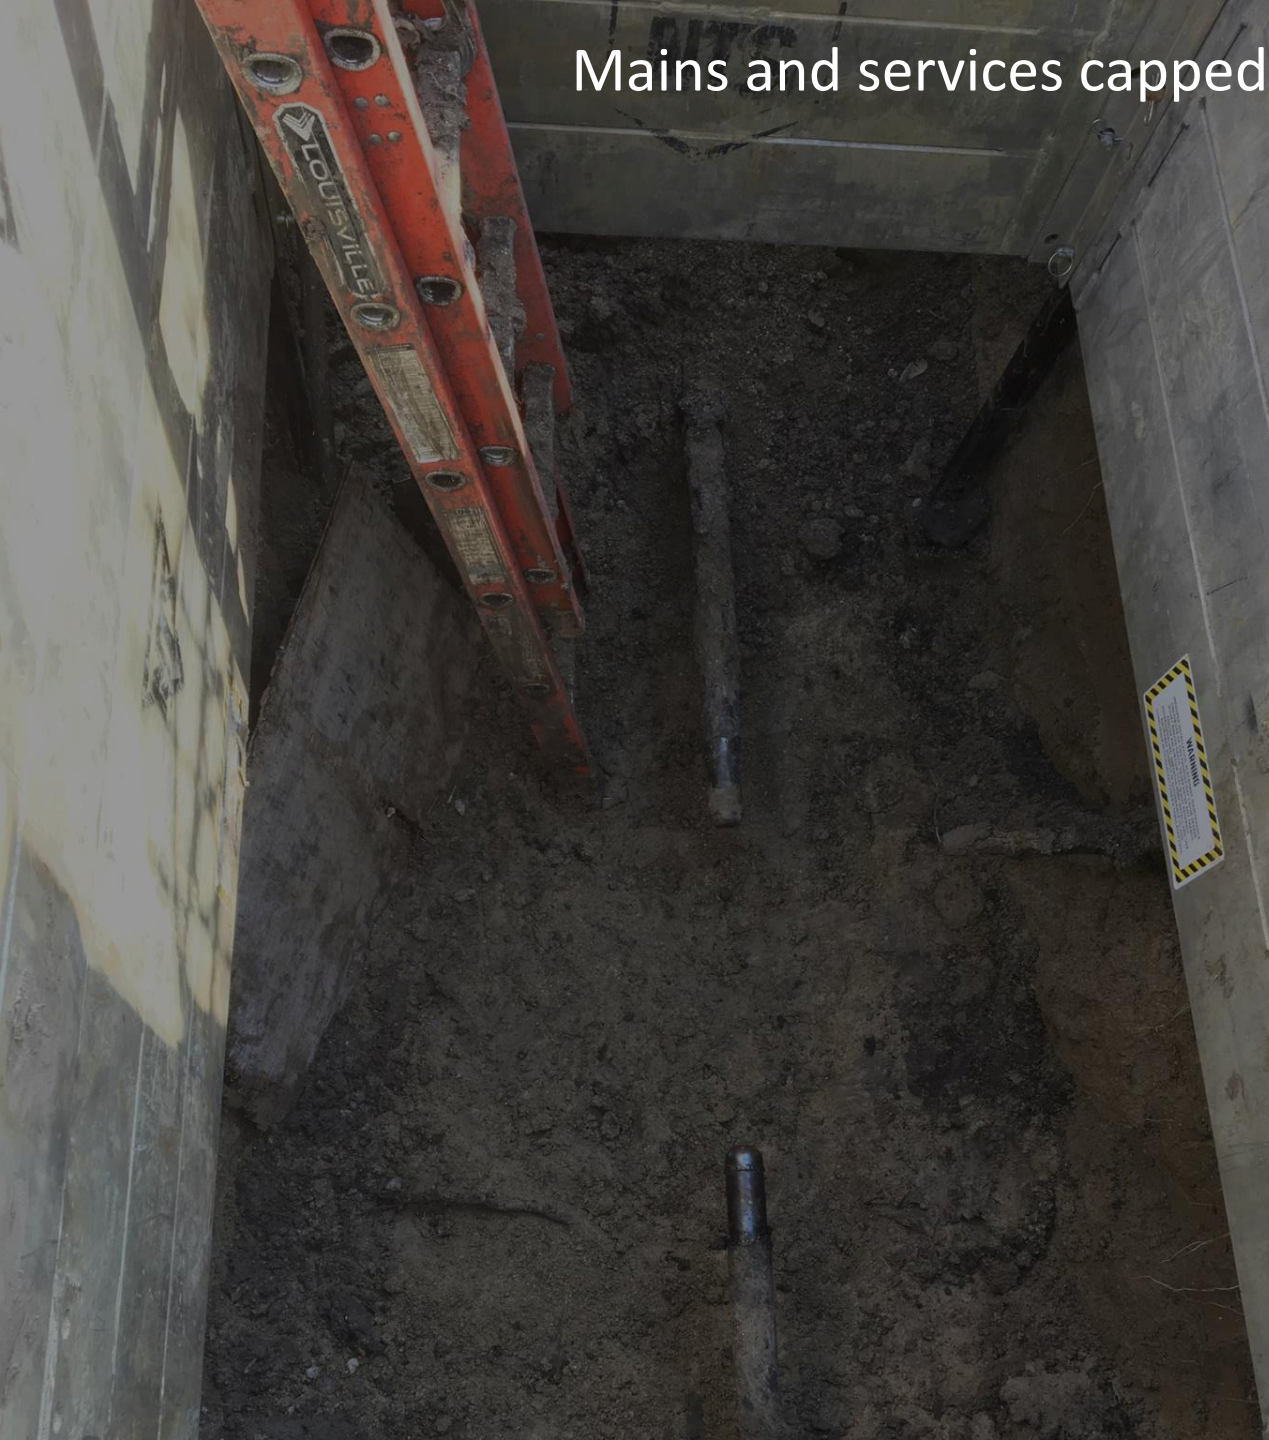
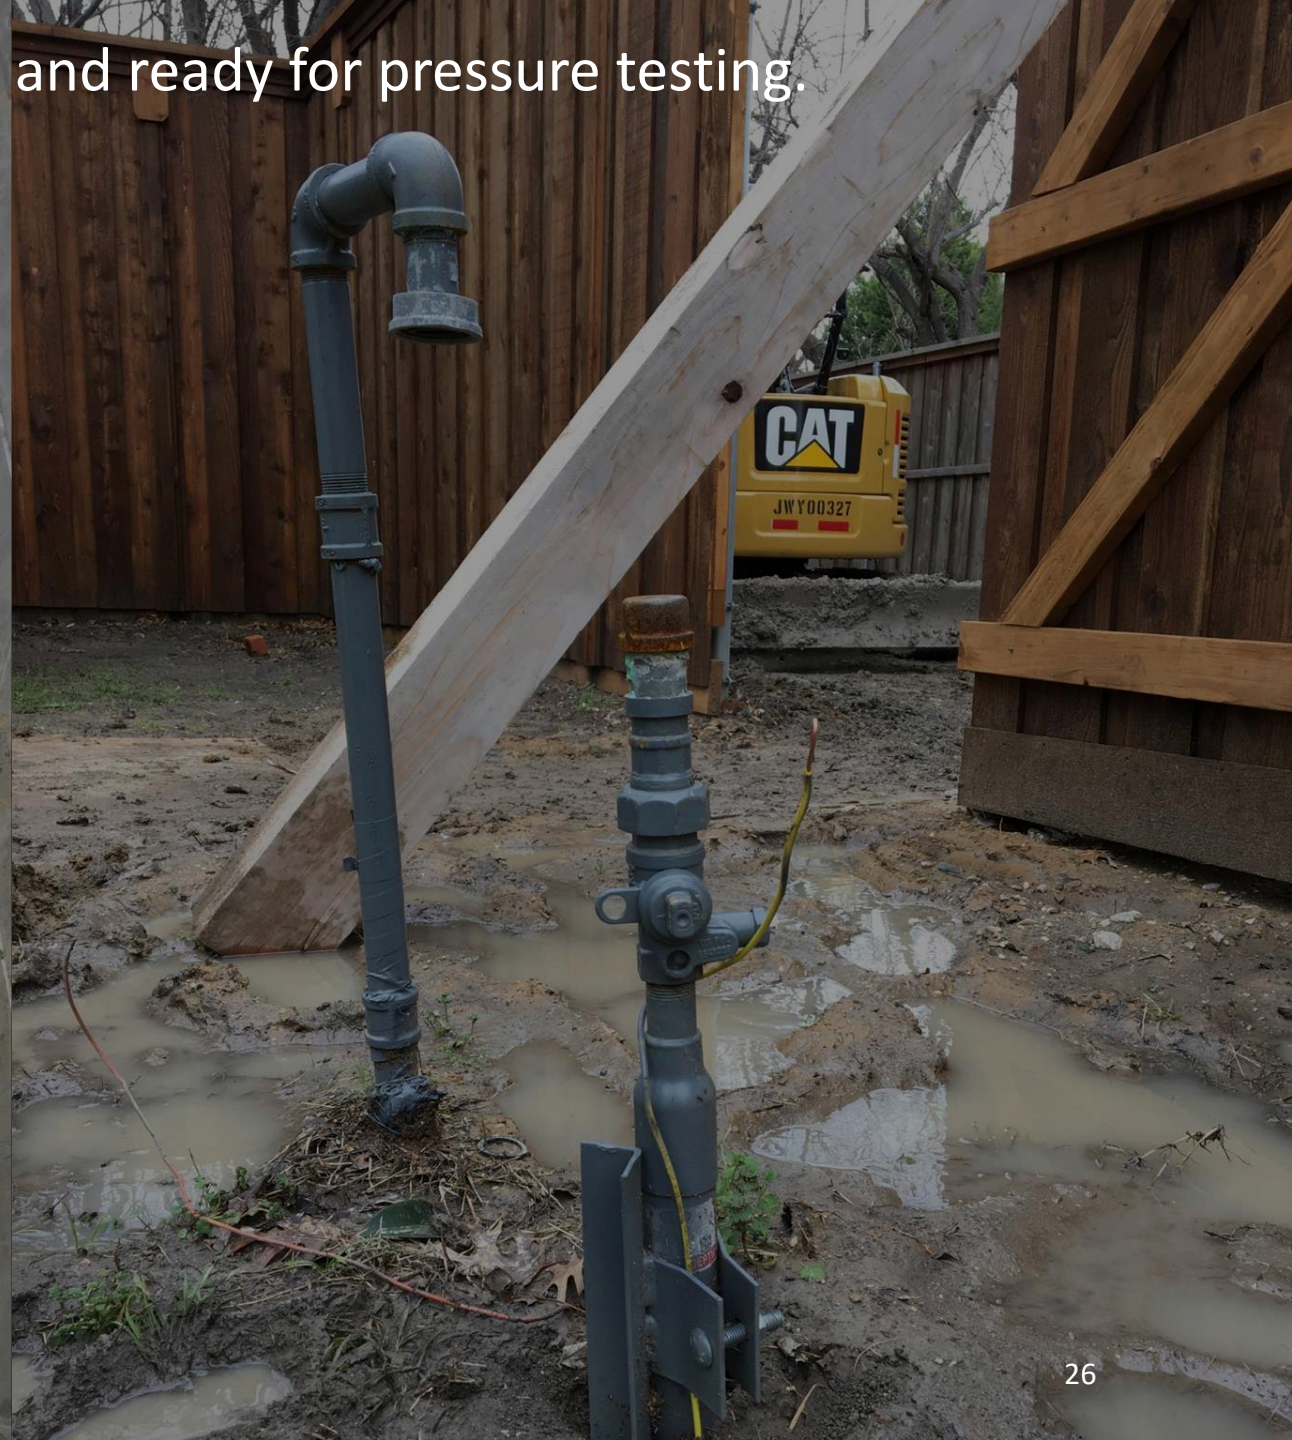
Mains and services capped and ready for pressure testing.

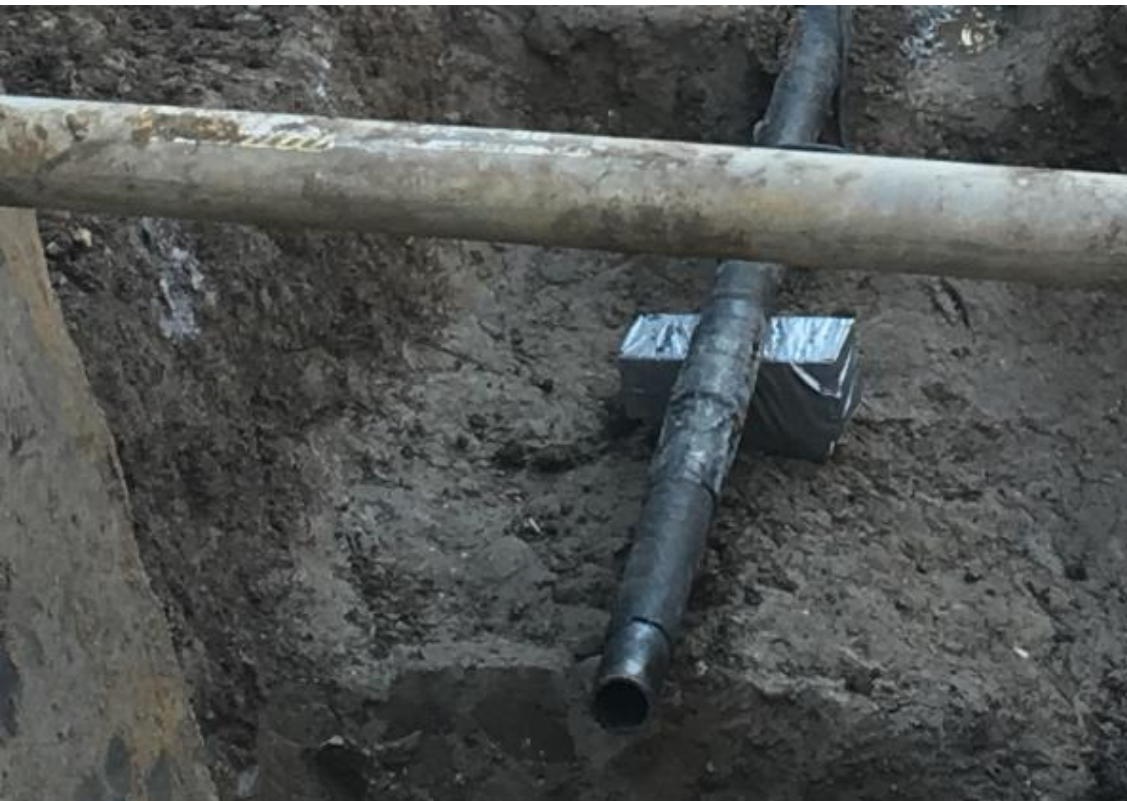
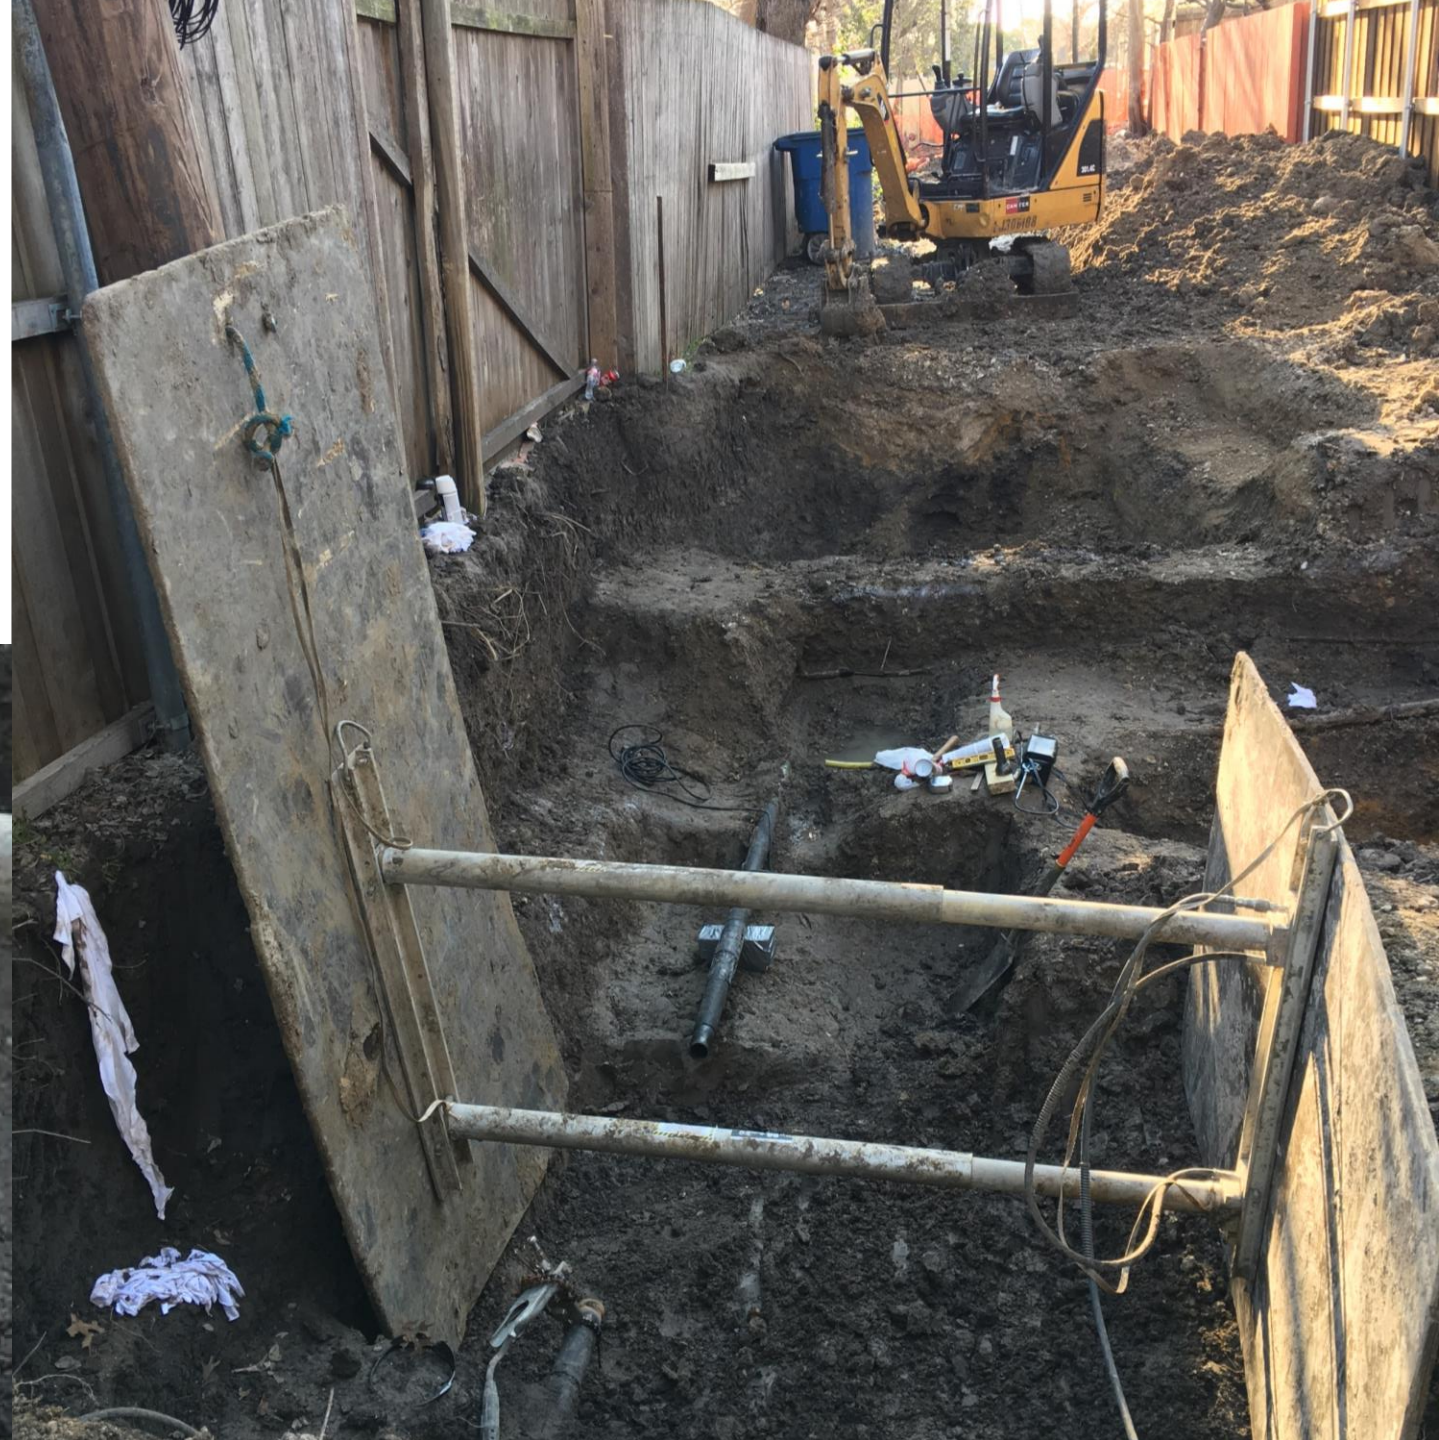
Be safe while working, What is wrong with this picture. A pressure test cap will be welded on for pressure testing in a few minutes. A compression coupling can be seen by support block.
